# **Process To Improve Reliability Of A Complex System Of Mature Design**

## **A MASTER OF ENGINEERING REPORT**

The NV-80 B-Kit, contracted by the US Army through PM FLIR and PM Night Vision (NV), is a Forward Looking Infrared (FLIR) scanning receiver that collects radiation in the 8-12 micron spectral region across two different two-dimensional fields of view (FOVs) using a second generation IR focal plane array. This system performs a variety of signal and image processing and outputs electronic video signals. The NV-80 B-Kit is composed of a Sight Unit (SU) and the Second Generation Electronics Unit (SGCEU). Both the SU and SGCEU consist of several modules, each having pre-defined interfaces and physical connections, defined in the Interface Control Document (ICD), that allow the NV-80 B-Kit to function as a stand-alone unit that requires only an external power supply, fixturing, card cage with interconnect, control interface and cabling in order to operate.

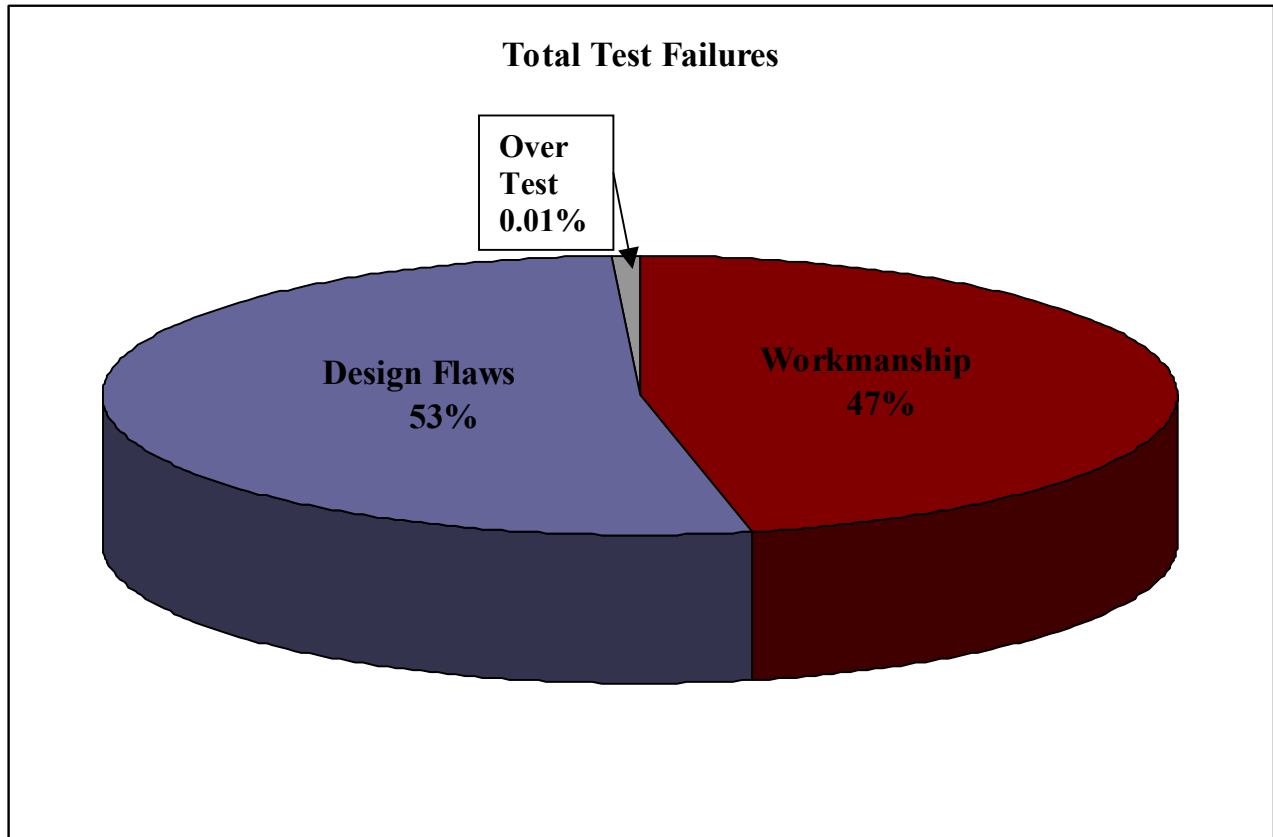
Figure 4-3-1. Total Test Failure Distribution, D or W

This figure shows that Design flaws made up 53% of the test failures and Workmanship errors made up 47% of the total test failures. This might mean that the manufacturing processes should be examined for areas where processes can be improved, or for processes where the design is too complicated and should be simplified. Another explanation might be that there is too

much throughput in the manufacturing process for the operators and technicians to be able to do quality assembly work.

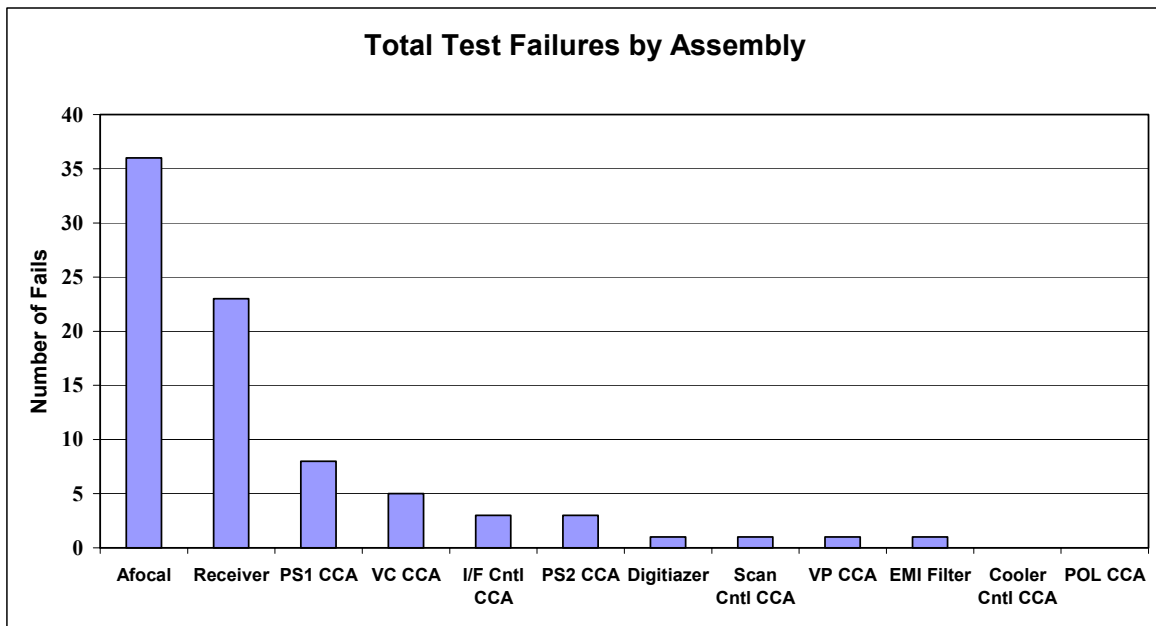
Figure 4-3-2. Total Test Failures by B-Kit Assembly

This figure shows that, by a large margin, the two B-Kit assemblies that may yield the largest reliability increases through redesign are the Afocal (36 failures) and the Receiver (23 failures). Since these two assemblies contain most of the mechanical parts of the B-Kit, it is not unexpected for them to have the largest number of failures. The SGCEU fan is the only other mechanical part on the B-Kit. The other interesting feature of Figure 4-3-2 is that the Cooler Control CCA and the POL CCA have caused Zero failures.

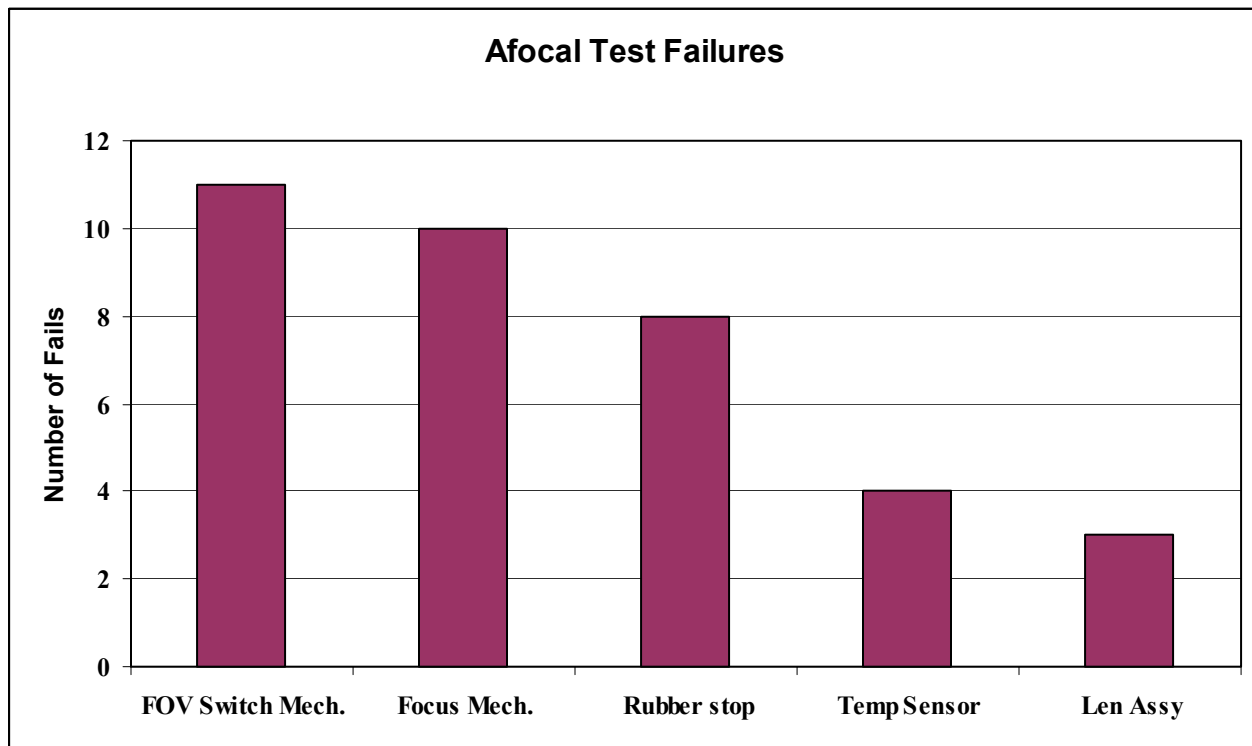
Figure 4-3-3. Afocal Test Failures by Subassembly

This figure shows that the FOV switch mechanism is the largest contributor to the Afocal failures in test, followed closely by the Focus mechanism. The third largest cause of Afocal failures in test is the Rubber stop.

This figure illustrates a weakness in examining all test data over the life of the system. The rubber stop was redesigned in 1999. The failures shown here all occurred prior to the redesign, none have been seen since the new rubber stop began use. Therefore, the rubber stop is no longer a valid design-change candidate, despite what the figure shows. Care must be exercised in using data collected over a 9-year time period.

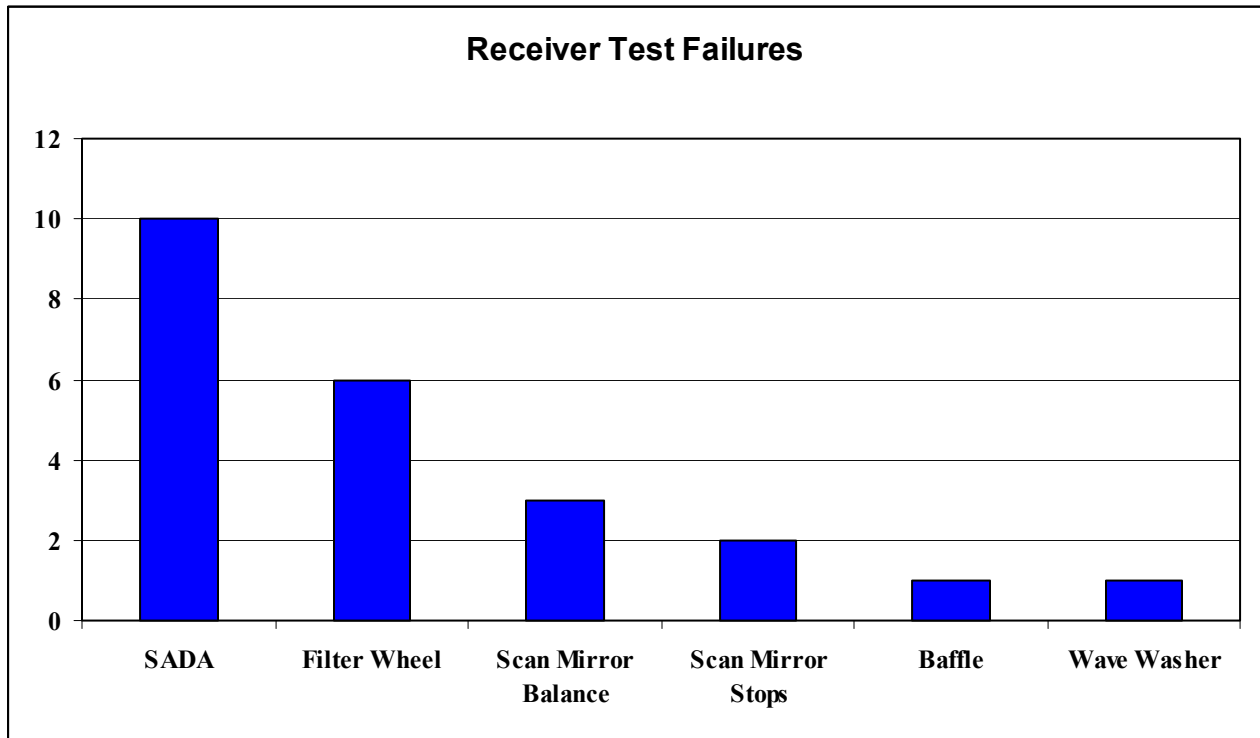
Figure 4-3-4. Receiver Test Failures by Subassembly

Figure 4-3-4 shows the ‘slice’ of Receiver subassemblies. This figure shows the largest cause of Receiver fails during test is the Standard Advanced Dewar Assembly, Type II (SADA II). Unfortunately, this subassembly is Government Furnished Equipment (GFE) to the system, so no redesign or control of reliability is within our power. The second largest contributor to Receiver test failures is the Filter Wheel subassembly.

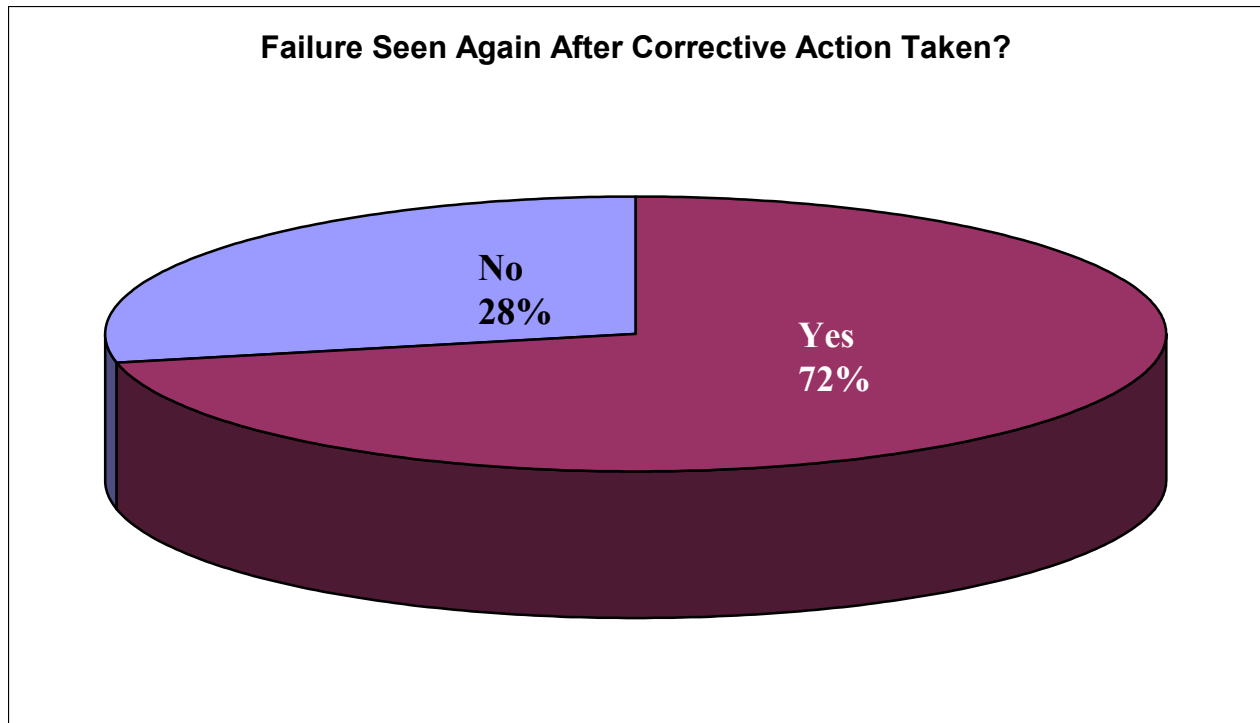
Figure 4-3-5. Test Failures and Proper Corrective Action

This figure shows that corrective actions was not effective in preventing the problem from recurring. From a systems engineering and design engineering perspective this is the most troubling of the ‘slices’. Corrective action was taken in the case of almost all of the failures. The only exceptions were those, like the SADA, where the corrective action was out of our control. The other failures that fall into this category are: Failure of Athermalization, Failure of Audible Noise on both the Afocal and the Filter Wheel assembly, failure of FOV at temperature, and the o-ring material. Of the 72% where the failure was seen again, one-third were design flaws. The remaining two-thirds were workmanship errors. This means that the corrective action, whether it was revision of assembly instructions, operator training, or color-coding of wires, did not alleviate the workmanship issue.

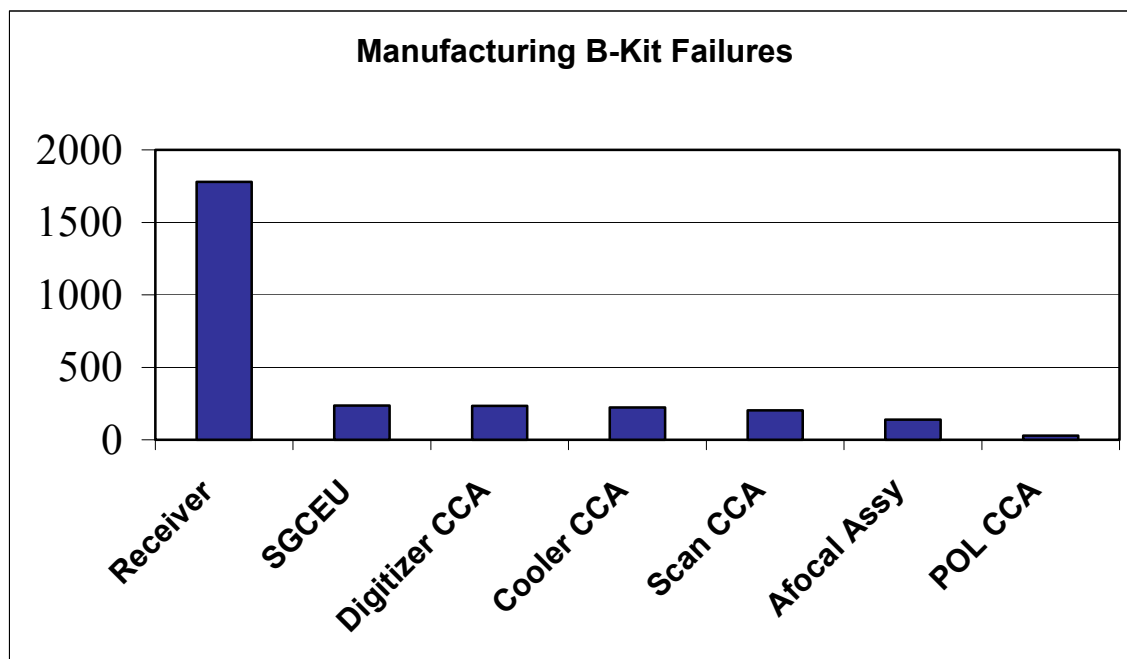
Figure 4-3-6. B-Kit Failures During the Manufacturing Process

The Receiver is the highest failure rate item, by a large margin. Next is the SGCEU, but the next items all have roughly the same failure rate. To date, Raytheon manufactures only the Receiver, Digitizer CCA, Scan CCA and Cooler CCA. The SGCEU, Afocal Assy and POL CCA are manufactured by another company, and sent for use as GFE. These items were

supposed to have passed a thorough burn-in process and Acceptance Test before arriving at Raytheon.

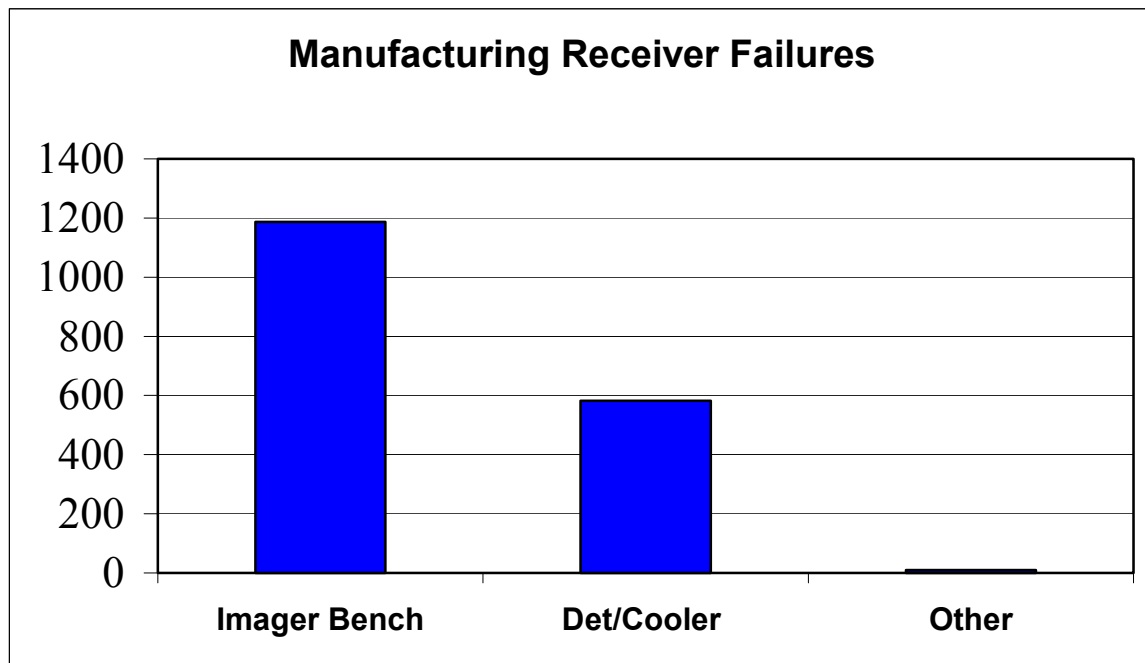
Figure 4-3-7. Receiver Failures During the Manufacturing Process

This figure shows the Imager Bench Assembly and the Detector/Cooler Bench Assembly are the problems in the overall percentage of failures (67% and 33%, respectively). This leads to the next cut—what parts of the Imager Bench Assembly are failing. This is shown in Figure 4-3-8.

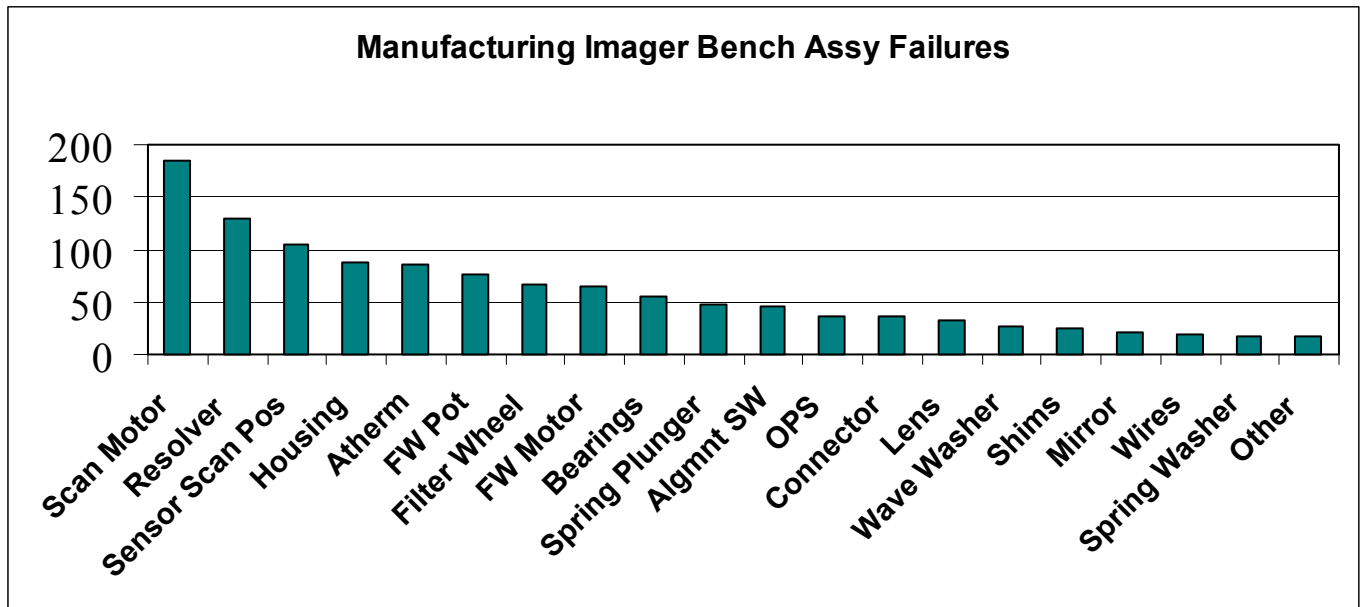
Figure 4-3-8. Imager Bench Assembly Failures During the Manufacturing Process

This figure shows that the Scan Motor is the highest failure rate item, with the Resolver second, and the Sensor Scan Position third. Again, this shows one of the pitfalls of using a FRACAS that shows data over the long life of the program. A problem with the scanner being

slightly off balance caused failures when the B-Kit was operated in the CIV and TIS modes because these modes instruct the scanner to scan in the opposite direction from the B-Kit. Until this interface problem between the Receiver and the SGCEU was tracked down, many Receivers were failed, and the problem could not be duplicated. Raytheon was testing the receivers in the

B-Kits mode, and the scanners were working fine. This problem was corrected almost 3 years ago, so a large portion of the Sensor Scan Position failures had been corrected prior to the last Reliability Growth test. A scan motor did fail during the last Qualification test, so scan motors are still a problem. A new motor is being sought that can handle the speeds required, but that can tolerate the arc motion generated by the scan mirror. The mirror traces an arc instead of a full circular motion that most motors are designed to handle.

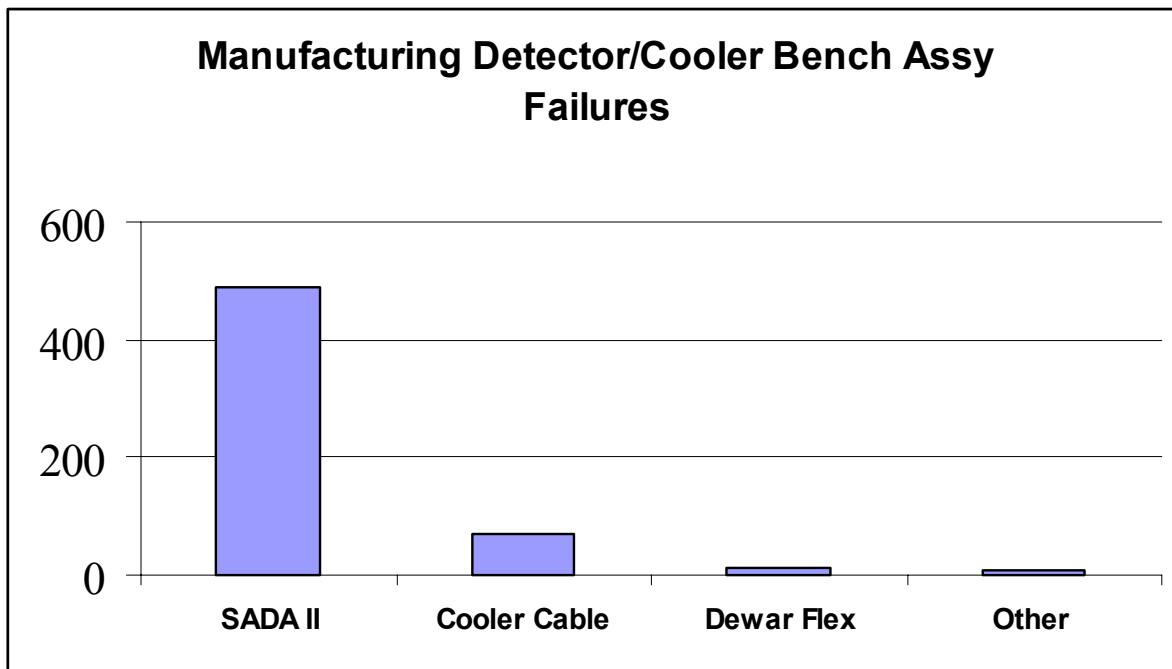
Figure 4-3-9. Detector/Cooler Bench Assembly Failures During the Manufacturing Process

From Figure 4-3-7, the second highest failure rate item in the receiver was the Detector/Cooler Bench Assembly. A further breakdown of the Detective/Cooler Bench fails is shown in Figure 4-3-9. This shows that the SADA II is the largest failure item in the bench.

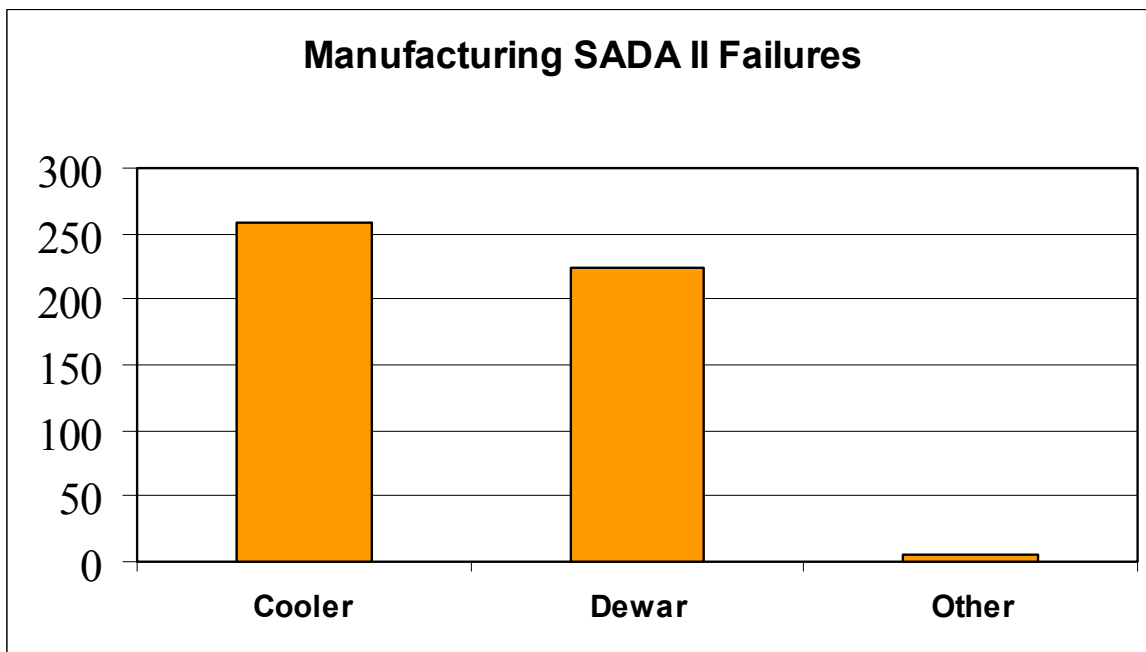
Figure 4-3-10. SADA II Assembly Failures During the Manufacturing Process

The SADA II Cooler causes the greater number of failures during the manufacturing process, but the Dewar is a close second. HTI also goes through a prescreening process to weed out problem SADAs before they are installed in a Detector/Cooler Bench assembly. The current prescreening process for SADAs catches about 2% of the problem SADAs. The rest make it into the B-Kit and are found at various stages in the manufacturing process.

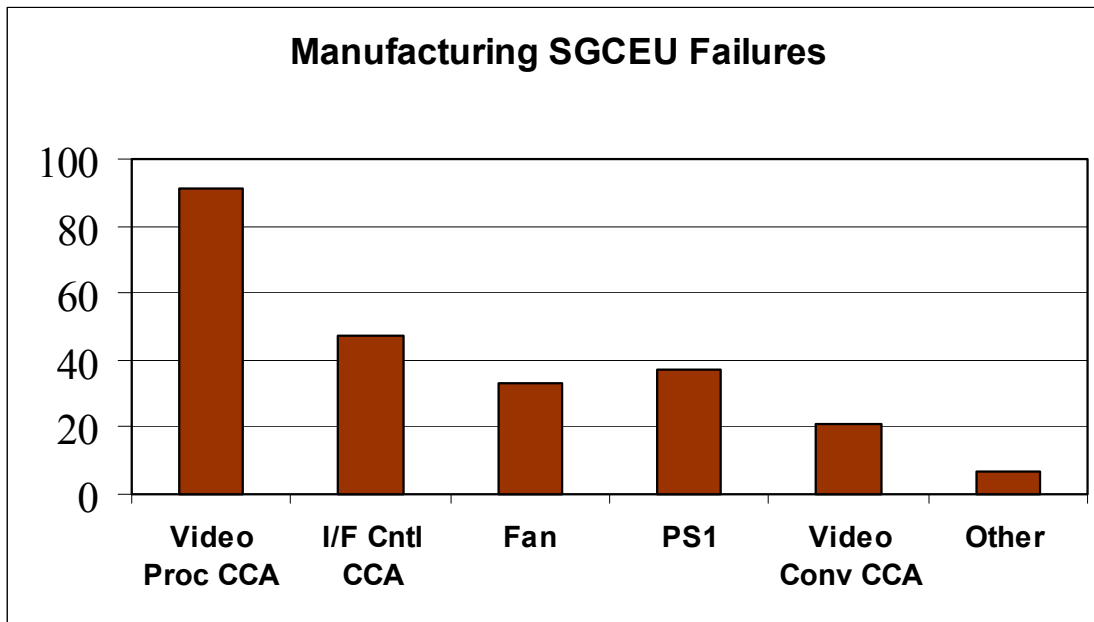
Figure 4-3-11. SGCEU Assembly Failures During the Manufacturing Process

Referring back to Figure 4-3-6, the B-Kit manufacturing failures, the second highest failure rate item was the SGCEU. A second cut shows which items in the SGCEU are failing. These are shown in Figure 4-3-11. This shows the Video Processor CCA to be the highest failure rates item. This may be because Raytheon manufactures the Video Processor CCA, while another company manufactures the SGCEU. Raytheon sends the Video Processor CCA as GFE to this other company. The SGCEU may have other failures that are not included in this database because the entire SGCEU is returned to the other vendor for repair.

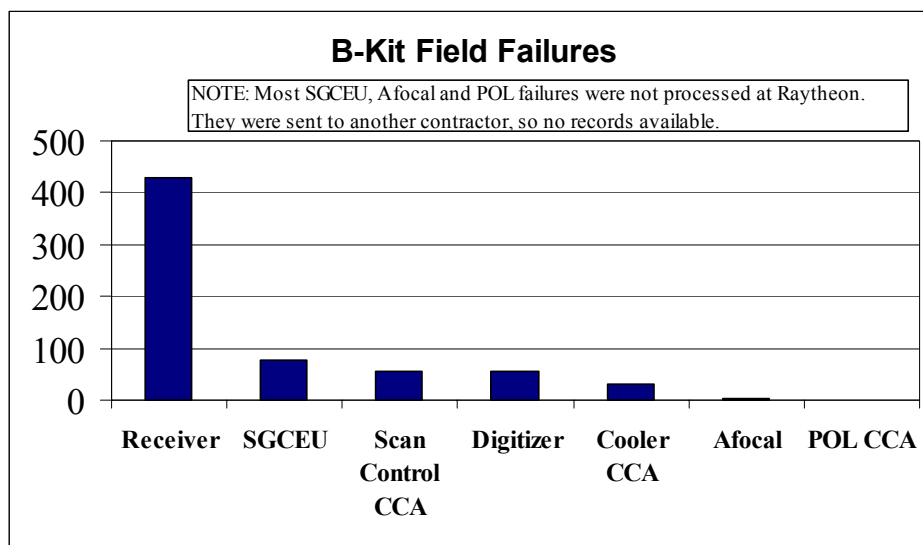
Figure 4-3-12. B-Kit Field Failures

One example of the ‘slice and dice’ for the field failures of the B-Kit is to look at the entire database, without any filtering. Figure 4-3-12 shows the B-Kit field failures. This figure shows that the Receiver is the highest failed item, just as it was in the manufacturing failure data. The Afocal failures are not handled by Raytheon, so they could be the highest failure rate item for the B-Kit, as is shown in the B-Kit test failures (Figure 4-3-2), but that is not part of the Raytheon database.

Of the roughly 2044 Receivers in the field, 429 (21%) have been returned for failures. If the Receiver had the same reliability numbers as the other B-Kit components, it would be reasonable

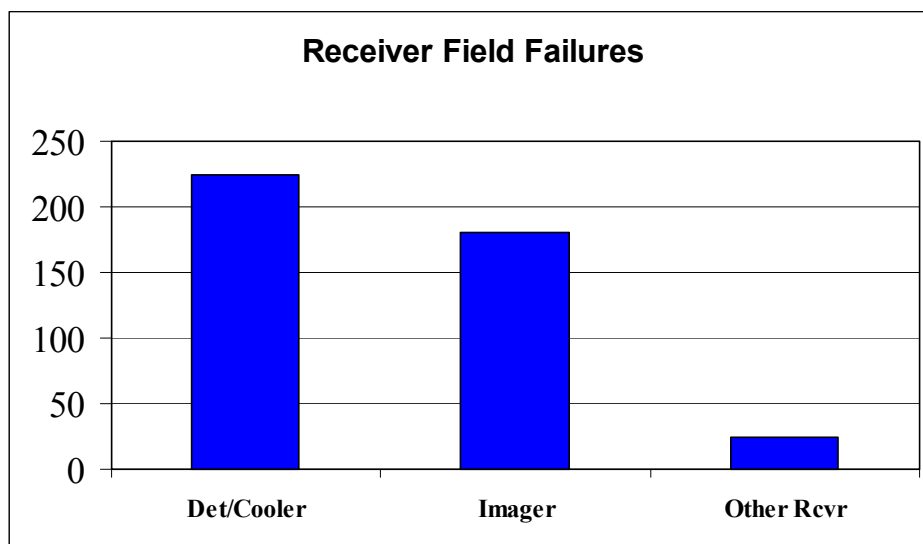
Figure 4-3-12. Receiver Field Failures

Figure 4-3-13 shows which receiver components are failing. It is seen that the Detector/Cooler Bench Assembly has the highest failure rate. The Imager Bench Assembly follows as a close second. This correlates closely with the manufacturing failure data, and, with the exception of the Afocal, also tracks the test failure data. The Afocal is returned to another company for field failures, so Raytheon has no information on those failure numbers.

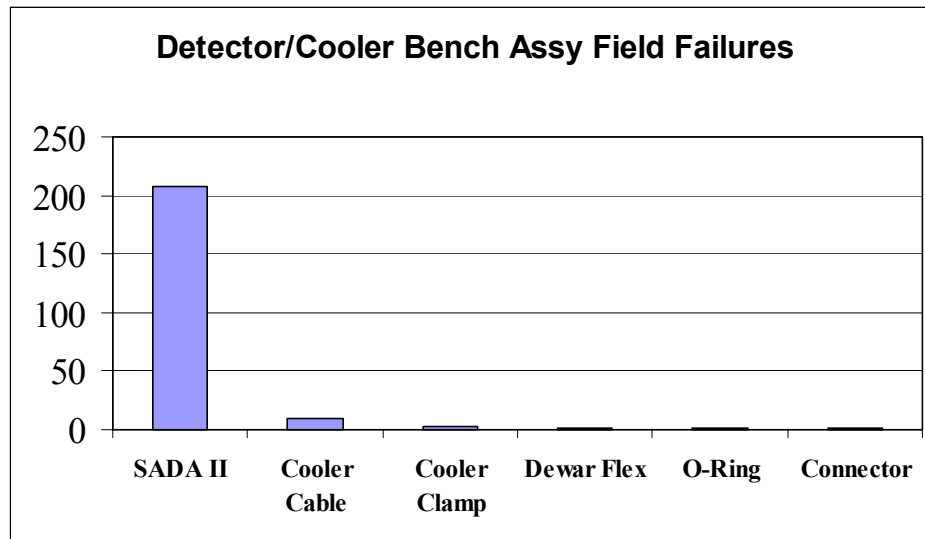
Figure 4-3-13. Detector/Cooler Bench Field Failures

Following the process, the next cut is to examine the components of the highest failed item here. Figure 4-3-13 shows what parts of the Detector/Cooler Bench Assembly are failing. As shown, the SADA II has the highest failure rate in the Detector/Cooler Bench. The SADA II is made up of two parts, the dewar and the cooler. Figure 4-3-14 shows the failure rates of those components. The Cooler has the slightly higher failure rate than the Dewar. As previously stated,

the SADA II is GFE to Raytheon, thus no actions taken by Raytheon can increase the reliability of this component.

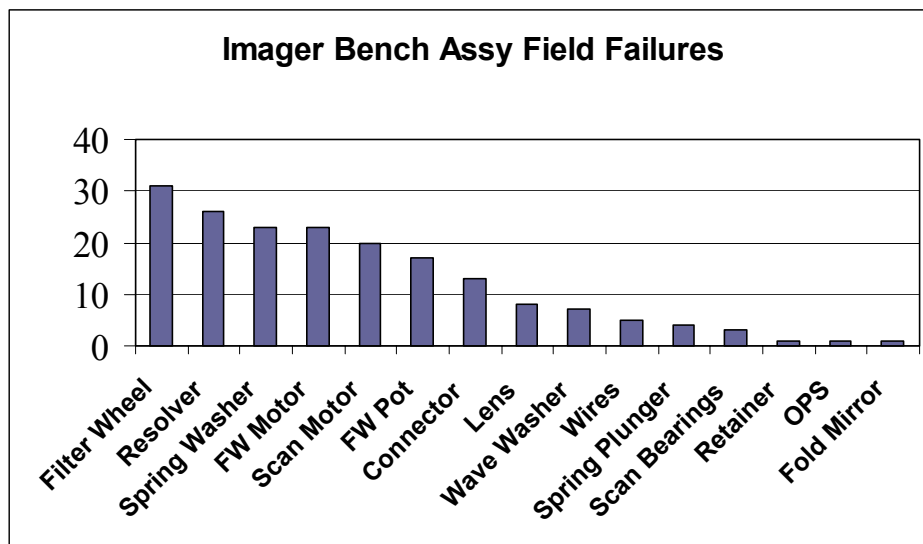
Figure 4-3-15. Imager Bench Assembly Field Failures

Since this assembly is manufactured by Raytheon, actions can be taken to improve the reliability of these components. The filter wheel has the highest failure rate, followed by the Resolver, the Spring washer, the Filter Wheel Motor, the Scan Motor and the Filter Wheel Potentiometer. Again, this figure demonstrates one of the dangers of using data covering a large period of time. Over the nearly 3 year span of this database, some of these problems have already been addressed. One Filter Wheel problem, the breaking of gear teeth as the wheel was driven into its stops, was corrected with the incorporation of soft stops. This has not eliminated all Filter Wheel problems, but did address about 30% of the failures shown in the figure. The resolver remains an open problem. The Spring Washer and Spring Plunger were a combined problem that
